## Byron Residents' Group Submission to NSW Coastal Panel Belongil Rock Walls

**Development Application number:** CP 17-001

Ralph Lauren Pty Ltd, Coastal Protection Works at 1 and 1A Don Street, Byron Bay

**These 4 proposals for the construction of rock walls at Belongil are strongly objected to.**

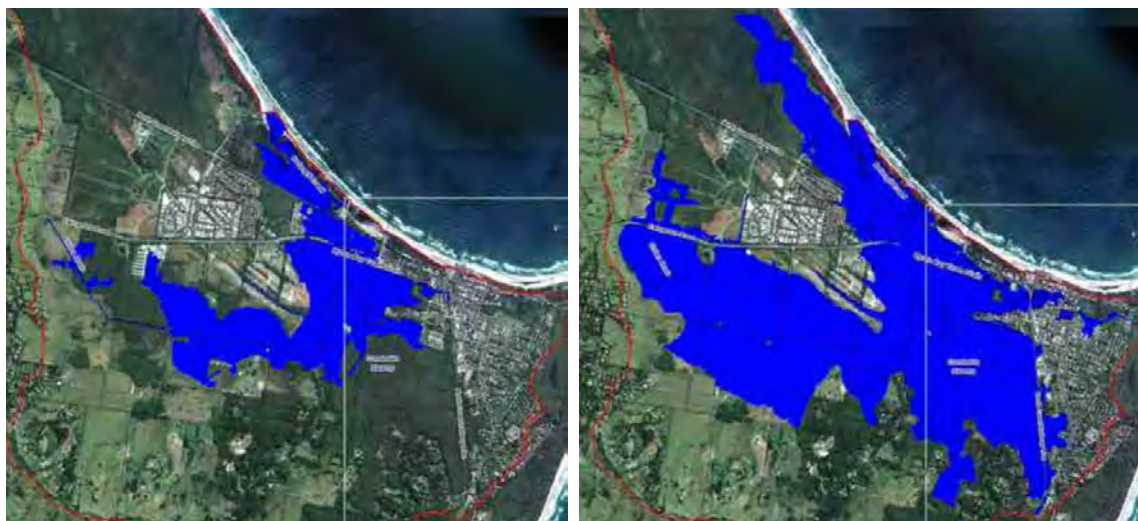
**Belongil Estuary inundation. LEFT** By 2100 land that is now only inundated in a 1:100 storm event will be inundated several times a year by Spring tides (Mean High Water Spring tide). **RIGHT** By 2100 the area inundated by 1:100 year storm events will be far more extensive (BMT WBM 2013).

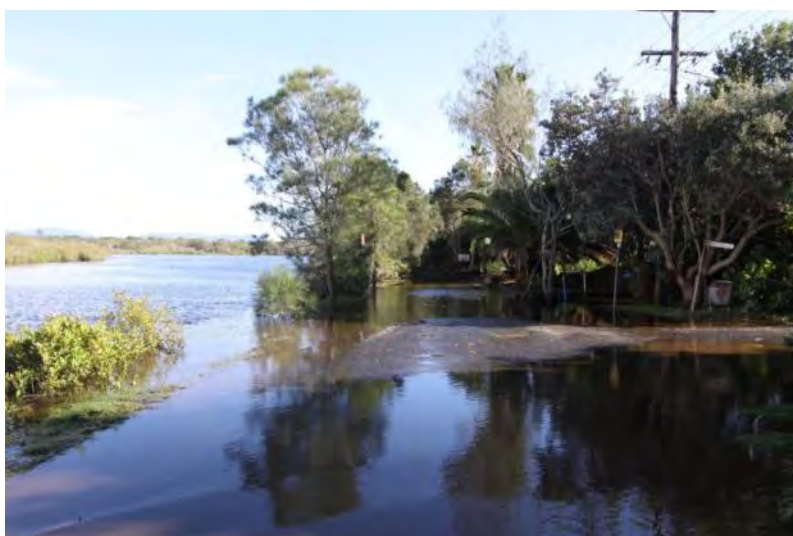
**As sea-levels rise so does the estuary, bringing Belongil under attack from both sides. This photo was taken in the vicinity of Manfred St in 2009. In the June 4 2016 event the estuary was reported as rising almost half a metre above the road in this vicinity, flooding the**

**ground floor of houses, cutting off power supplies and severely damaging several cars (Byron Shire News 9 June 2016).**

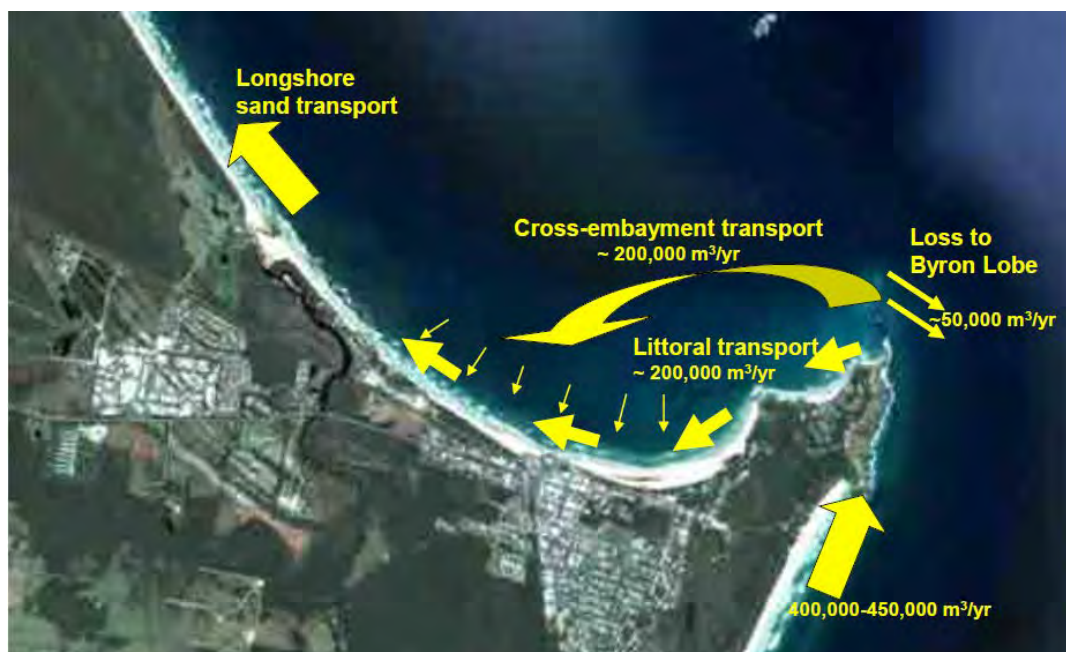
**Conceptual longshore sand transport system (Patterson 2010), coastal recession in the embayment is considered to be primarily a consequence of more sand leaving the bay than entering it.**

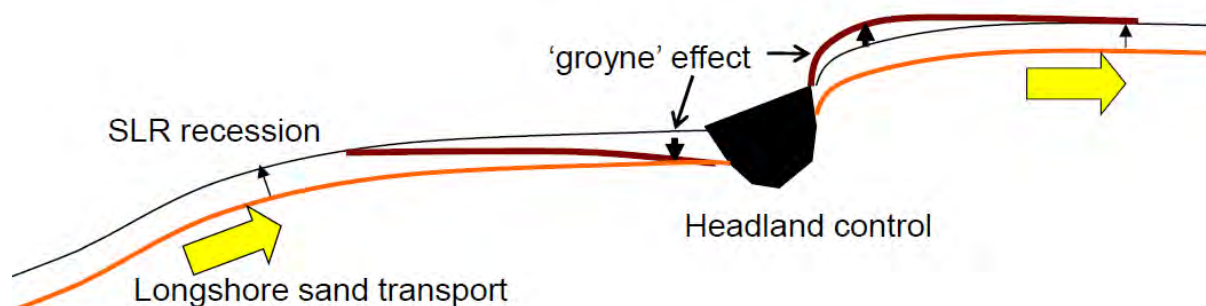
**The 'headland' or 'terminal groyne' effect decreases erosion on the updrift side of headlands or groynes, while increasing erosion downdrift (from BMT WBM 2013)**

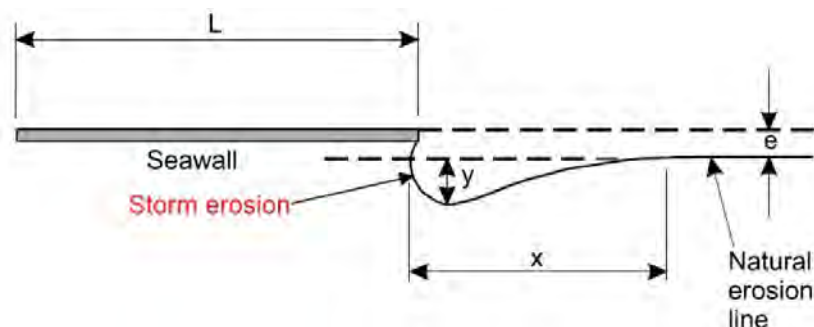
**End Effects of Seawall (Adapted from Komar and McDougal, 1988), where 'y' is the end effect specifically attributed to the seawall and 'x' is the length of beach affected. Note the zeta curve, showing impacts greatest at the end of the wall and tapering off over distance.**

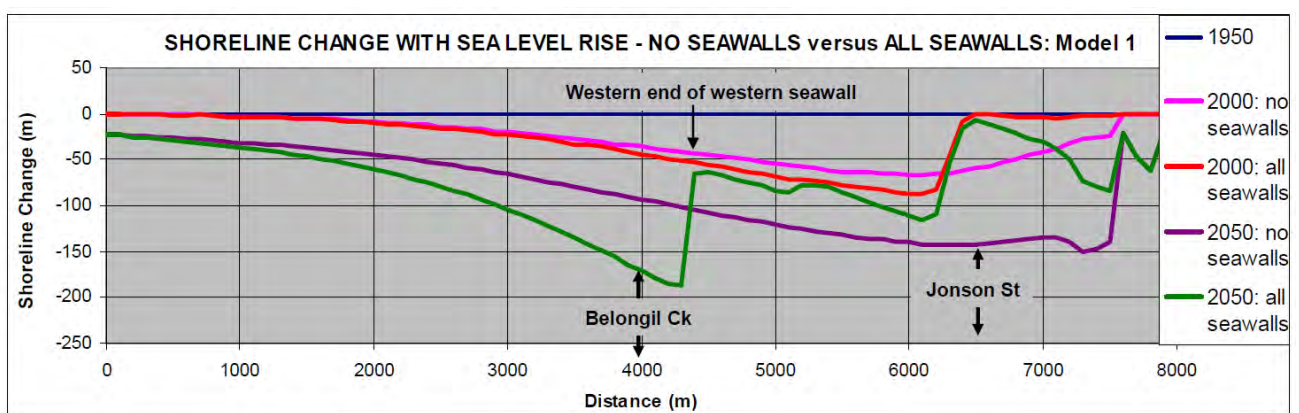
**Patterson (2010) Byron Bay Shoreline Erosion Research, modelling the effects of seawalls in the Byron embayment as at 2000 and out to 2050. Note the differences between recession with and without seawalls and the accelerating impacts.**

Patterson (2010) also found from the results of his modelling that the Jonson Street seawall had some initial impact on the erosion at Belongil Spit, and that the subsequently constructed seawalls along Belongil Spit have affected the erosion further west. Patterson (2010) also found that the erosion was *"in significant part, the result of natural sand losses from the beach system"*.

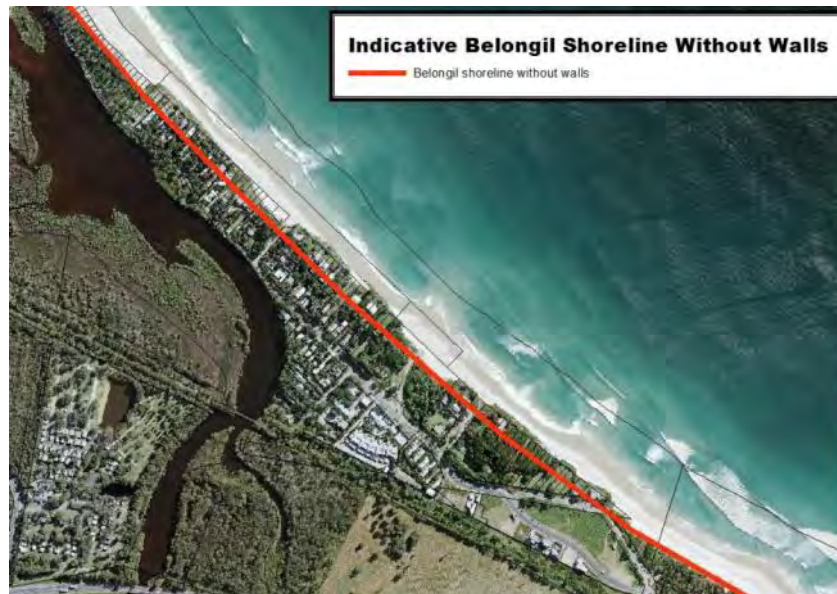
**Indicative present shoreline in the absence of current walls. The walls now mostly project 30-47m into the active beach system and frequently have no beach left in front of them. Note that this line does not reflect the shoreline if the seawalls were removed as there would be an initial realignment seaward (particularly to the west) in the absence of rockwalls.**

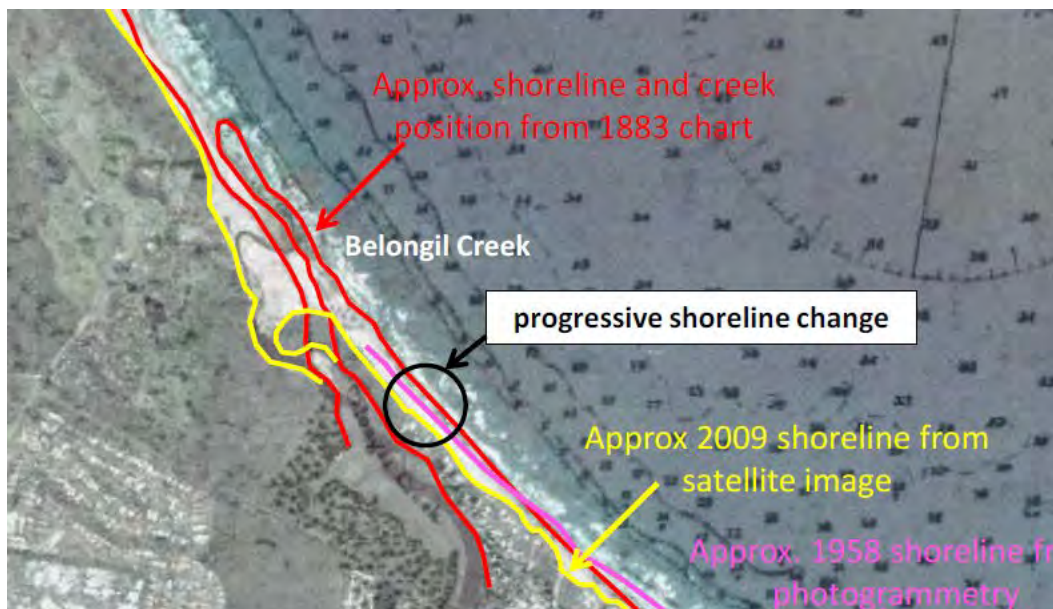
**Historical shorelines: 1883 Chart, 1958 photogrammetry & 2009 satellite imagery (Detail of Fig 4.8 from BMT WBM (2013).**

Early mapping shows the mouth of the creek further to the north. This indicates that with ongoing coastline recession, aided by artificial openings, the mouth has retreated to the south. While there has been landward recession around the mouth, the estuary in the vicinity of the end of the rock walls has not moved since 1883. Given that erosion is being focussed at the end of the rock walls any future migration of the estuary mouth is likely to be caused by a breakthrough at that location, rather than a gradual process.

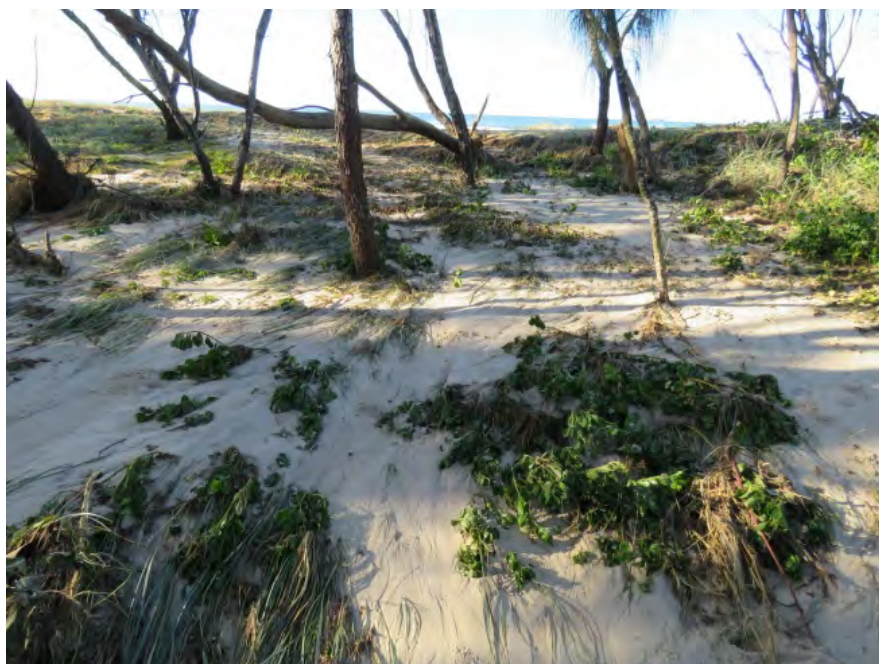
**The costs of rock seawalls. LEFT: In the June 2016 over-wash occurred towards the end of the sand spit, which has apparently been occurring for some time.**

Since 1999 significant parts of the Cumbebin Swamp Nature Reserve and Council's Community Land on the Belongil Spit have already been eroded because of the Belongil rock-walls. Most of the Nature Reserve and Council's Community Land and the Belongil shorebird area will be eroded away over the next 2-3 decades. The breakthrough of the sea to the Belongil Special Purpose Zone in the Cape Byron Marine Park will significantly affect its functioning. The over-wash and any inland retreat of the estuary will significantly affect the SEPP 14 wetland. (note that the groynes shown are not part of the current application but proposals put forward in Council's last draft CZMP to trap sand in front of the walls)

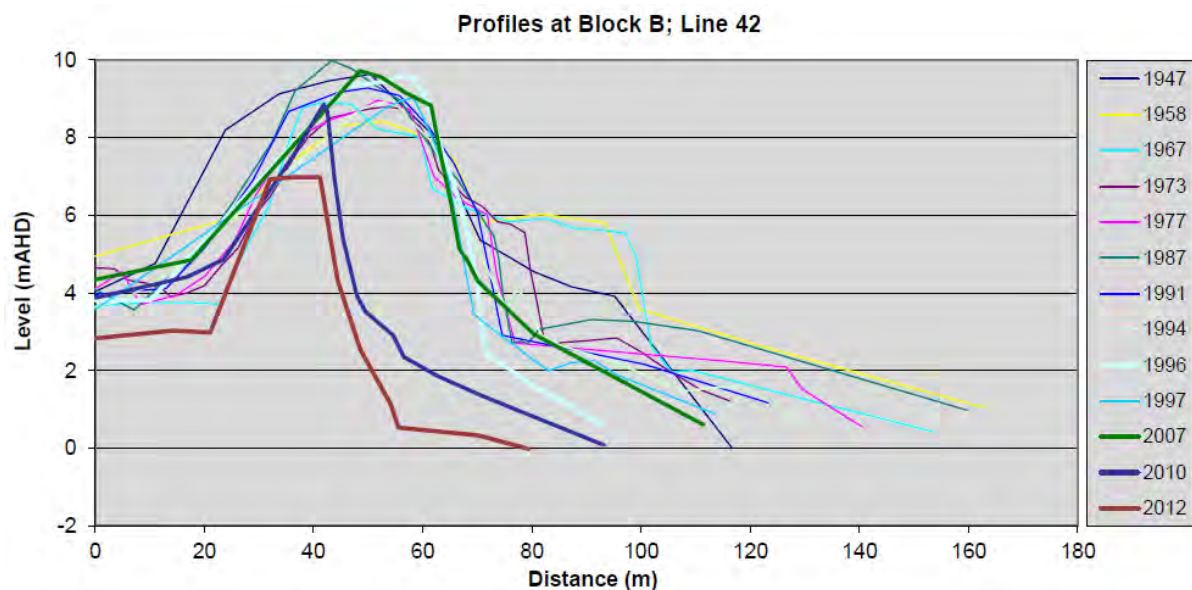
**Progressive erosion of the Belongil Spit (to the north of the seawalls) since 1947 (BMT WBM 2013). Note the major erosion since 2007, most likely in the 2009 events.**

*Recession in the unprotected shoreline north of the seawalls appears to be accelerating, consistent with a transfer of the overall net loss of sand from the whole area towards the northwestern (downdrift) end of the BBE.*

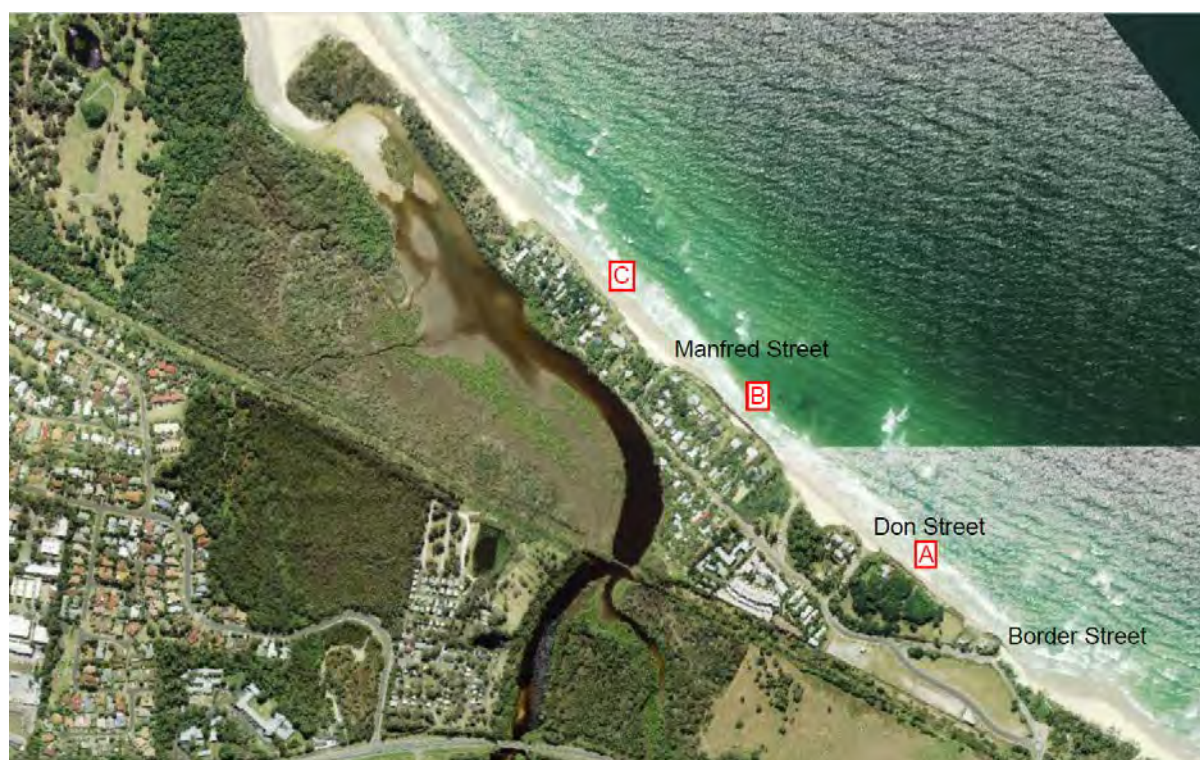
**Belongil Spit. Note the increased erosion at the ends of the three sets (A,B,C) of rock and rubble walls (image from Six Maps).**

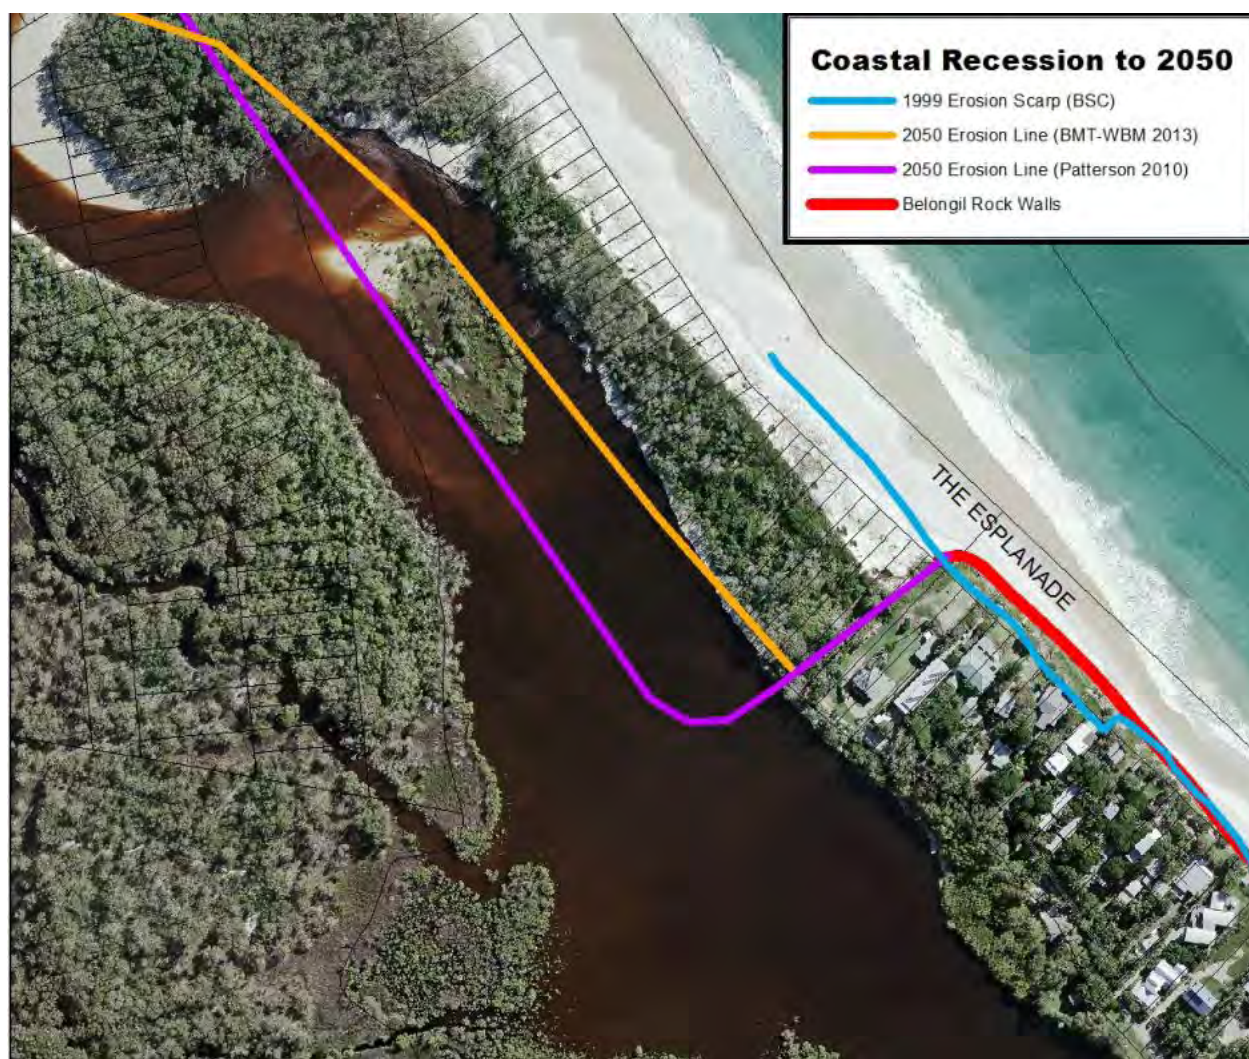
**Projections of Coastal Recession until 2050 with the Belongil seawall in place. by Paterson (2010, purple) and BMT WBM (2013, orange). Irrespective of which is right, it is evident that over the next 15-30 years the Belongil spit to the north-west of the proposed seawalls will be severely eroded, and that the sea will break through to the back of the estuary. Note the 1999 erosion scarp and The Esplanade lost in the 1980s. If a groyne is built at the end of the seawall it will significantly increase and accelerate the recession. By focussing erosion at their end, the seawalls are becoming a training wall for a new estuary mouth.**

The adopted hazard lines do not resemble the modelled impacts of the Belongil seawalls identified by Paterson (2010, Fig 32 - see below) which identifies that by 2050 erosion from the 2000 erosion scarp would be more like 75m without the Belongil rock walls and 140m with the rock walls, a difference of 65m (87%). Given that these figures were derived by the same author, the failure to accurately reflect the likely impact of seawalls on hazard lines at the end of the Belongil seawall needs to be explained.

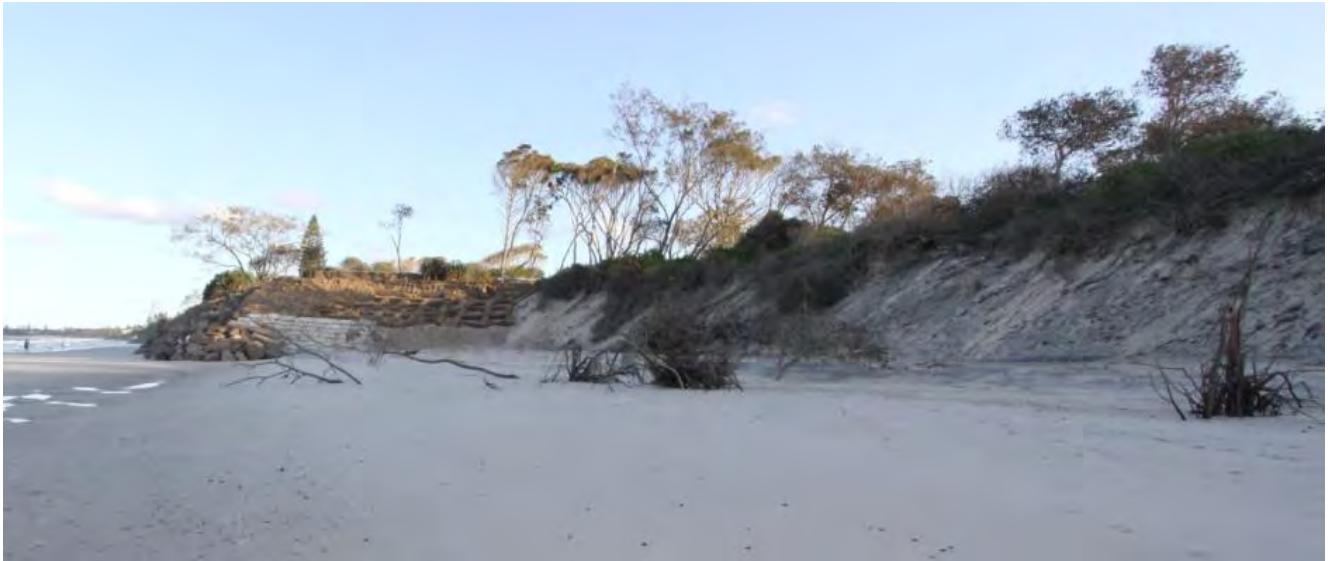
Erosion at end of rock walls 2009.

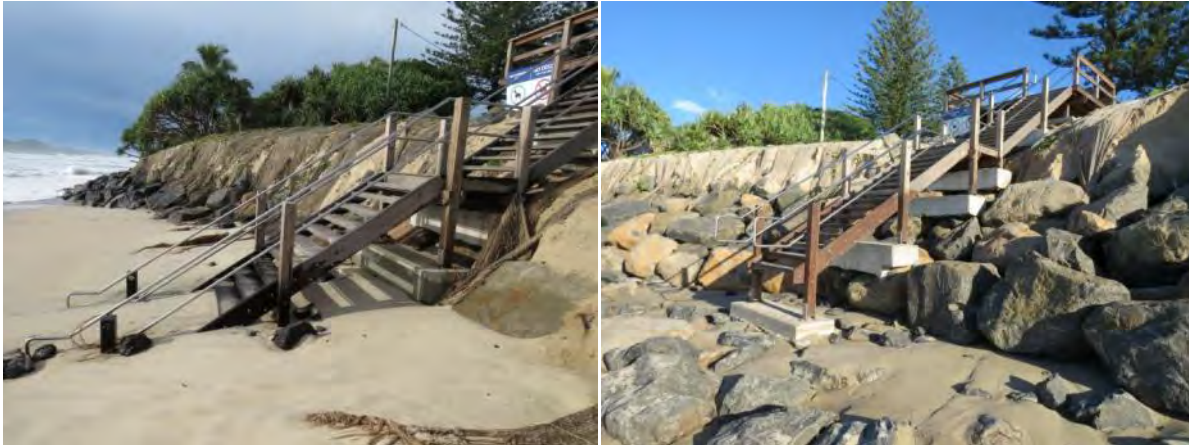
**Council's "Interim" Manfred Beach works were constructed in early 2016, they were subject to their first East Coast Low on 4 June 2016, which was relatively mild. When built the rocks were totally covered with sand and couldn't be seen. The photo on the left was 5 June, with continuing high tides significantly worsening the erosion by the 8 June (right). Most of the covering sand, matting and plantings were washed away and rocks strewn about.**

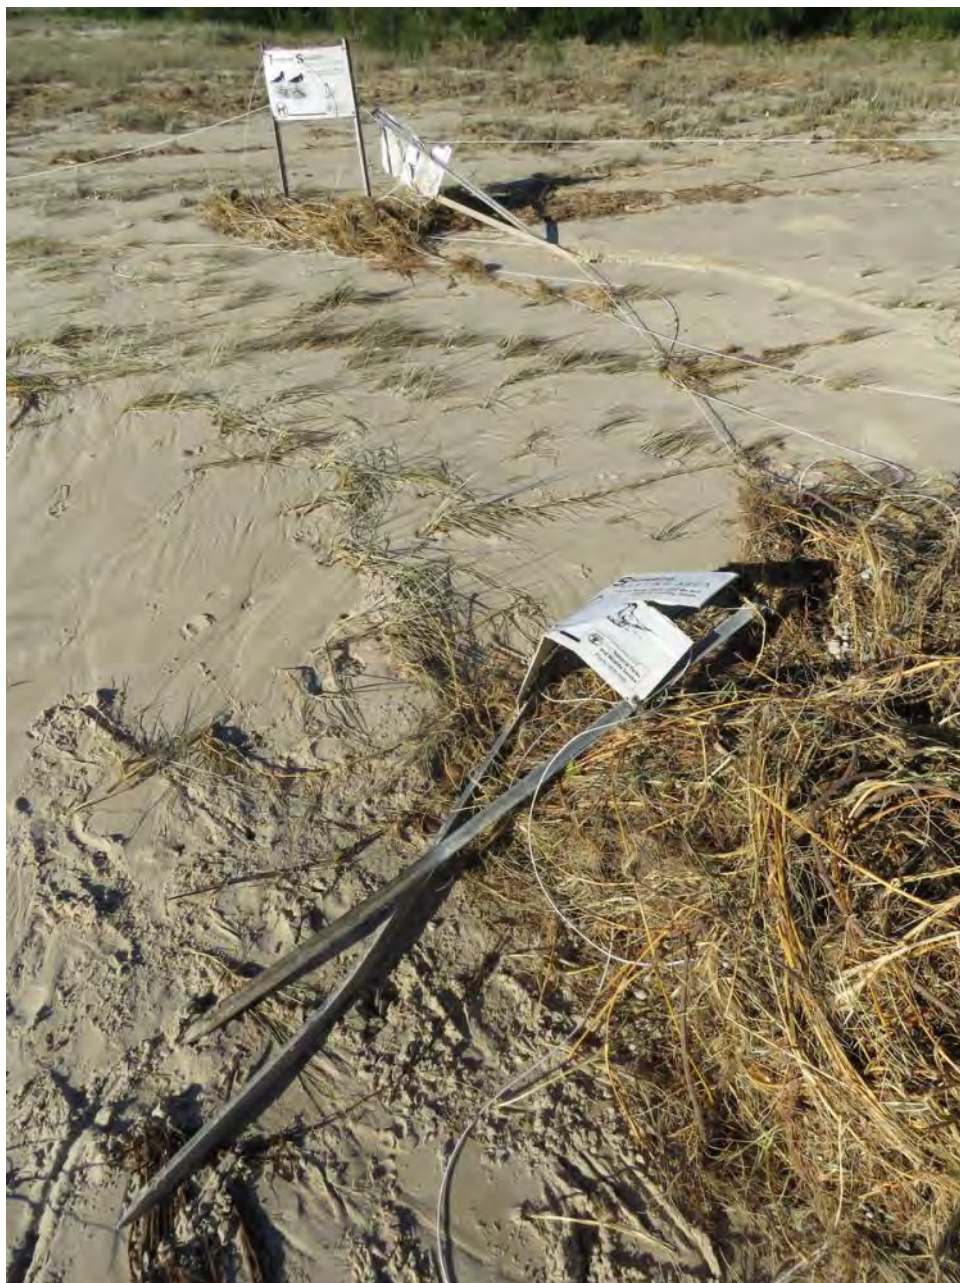
**Erosion of the core shorebird area occurred in the June 4 2016 storm. As sand volumes are diminished and erosion increased because of the Belongil rock seawalls the shorebird area will be more frequently inundated and rapidly eroded.**

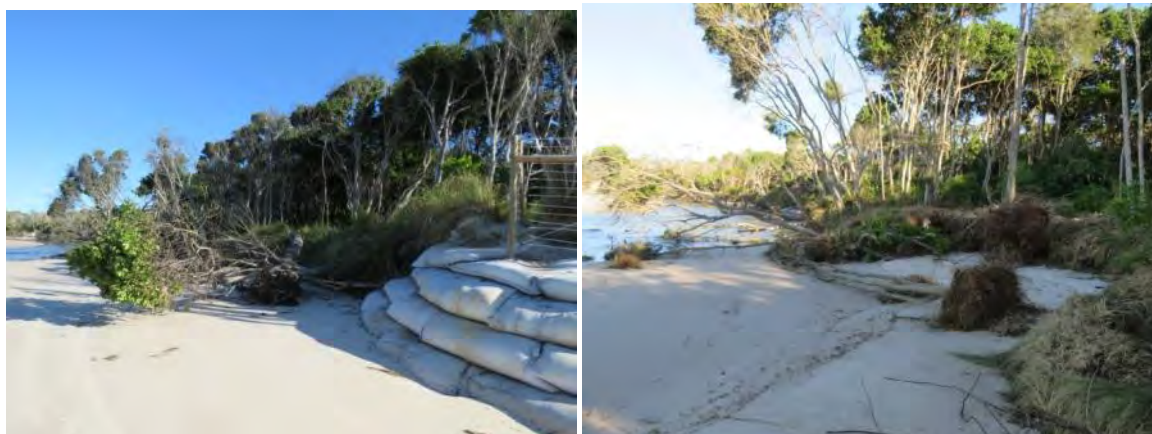
**Following the storm of 4 June 2016 there was significant erosion of the bank of the estuary and the EEC littoral rainforest at the "downdrift" end of Elements "interim" walls. Some of this increased erosion appears to have occurred on Crown land.**

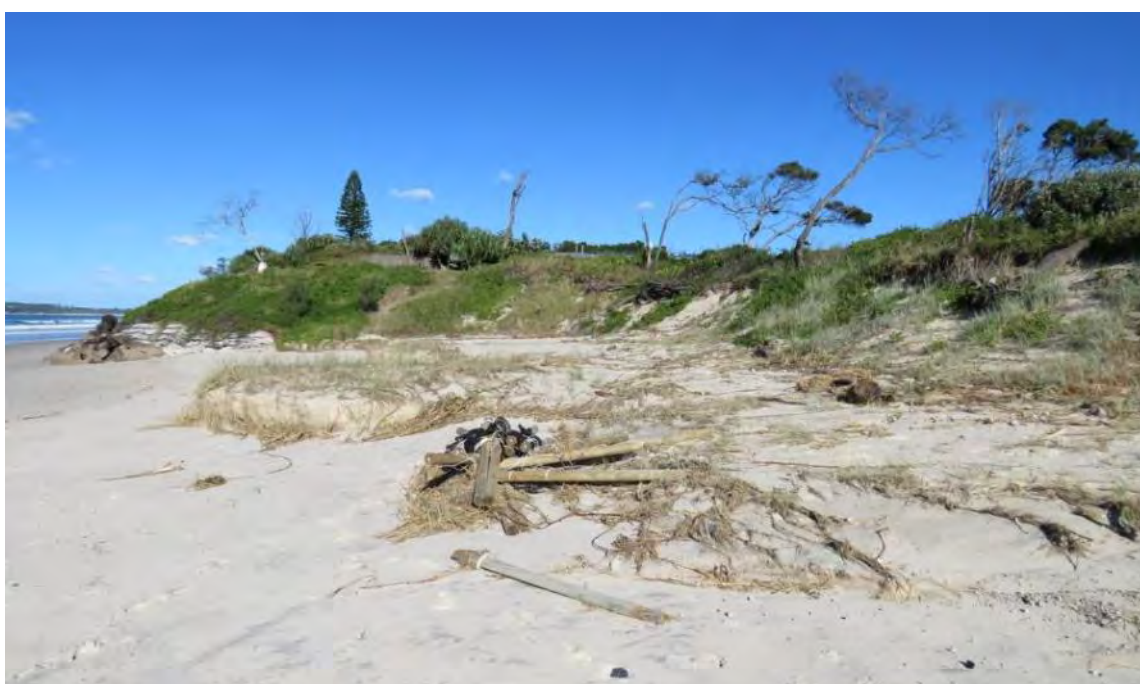
**Belongil spit at the end of the Belongil seawalls where the beach has been eaten back over 30m since 1999, taking out littoral rainforest and its buffer in the process. Note the tangled mess of posts and wire in the centre foreground from past regeneration attempts. To the right is remnant littoral rainforest.**

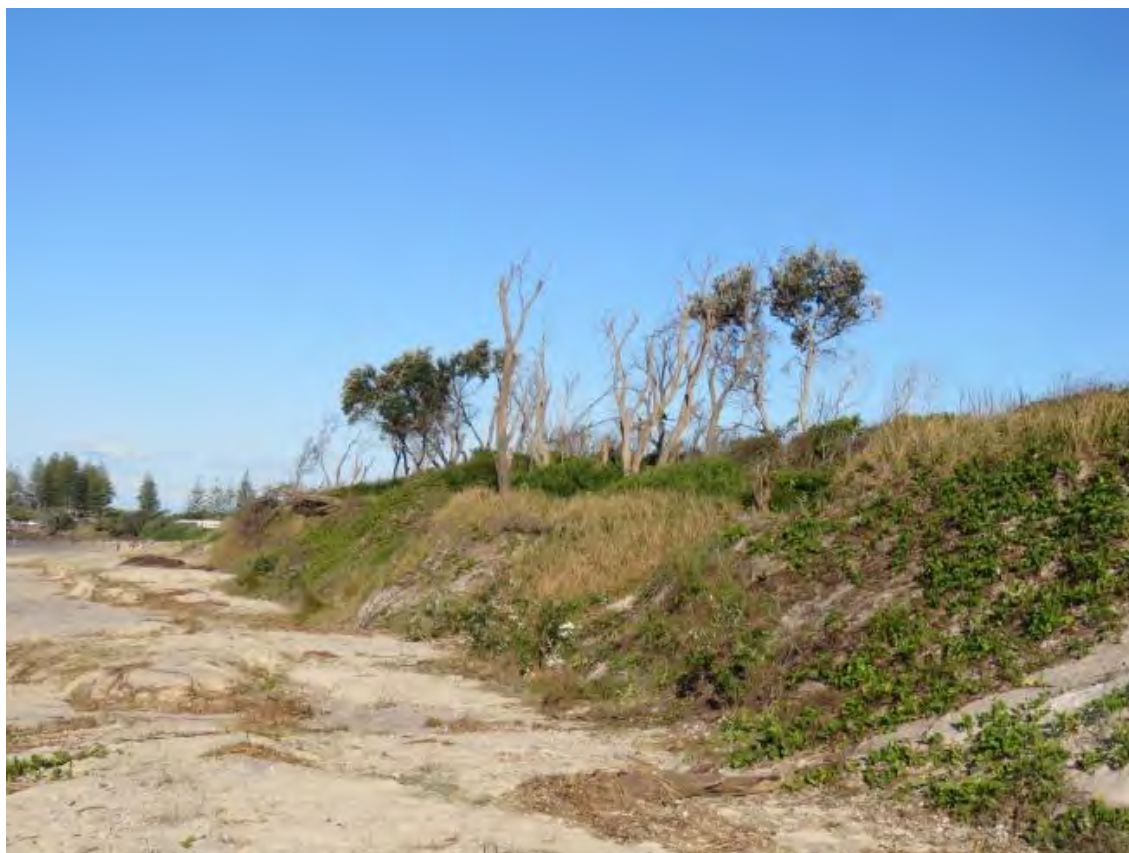
**The cost of the existing rock walls will get a lot worse if they are upgraded rather than removed. Since 1999, and particularly since 2007, extensive erosion and recession of the beach along the Belongil spit has eaten into the Cumbebin Swamp Nature Reserve, stripping away protecting vegetation and leaving the EEC littoral rainforest badly affected by wind intrusions and salt spray. This is the degraded nature reserve as at June 8 2016.**

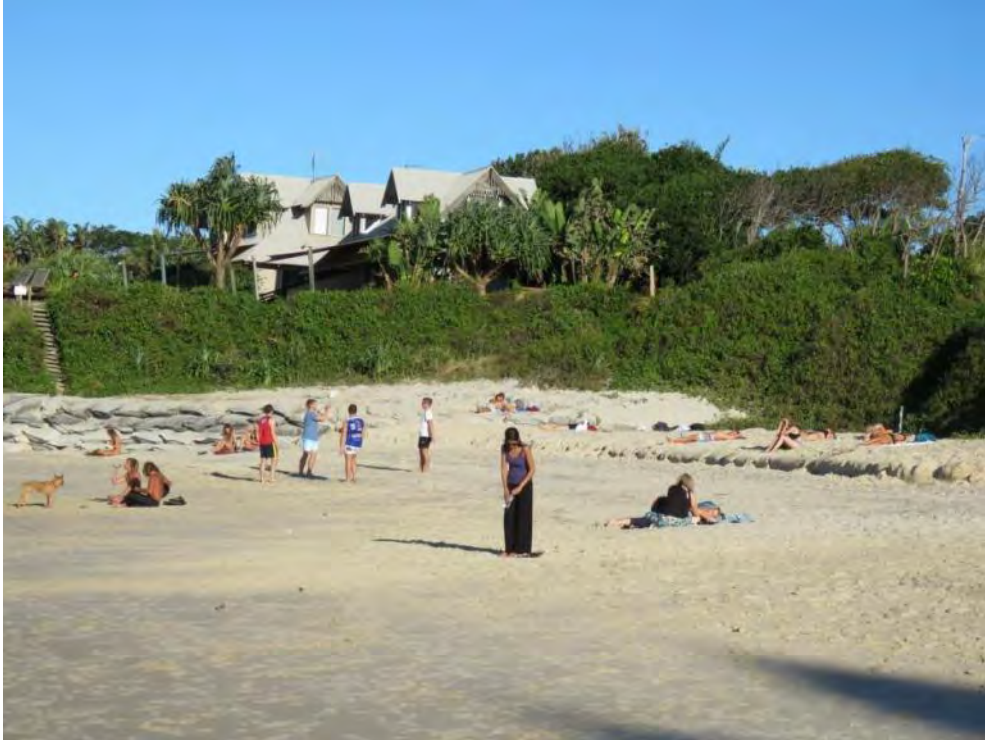
**The old jetty site is the only pocket of natural beach left in the area proposed for Belongil seawalls due to Council beginning to fill in breaks at Manfred and Don Streets. For most of the time this is the only dry beach available for recreation. Council now proposes to replace this remaining pocket with rocks.**

To date the rock and rubble walls fronting Belongil have been incomplete, with a major breaks at the old jetty site (150m) and until recently Manfred St (103m), and significant breaks in their continuity and structure elsewhere. Their reconstruction into a continuous rock seawall will significantly increase their impact, which will also accelerate with increasing recession and rising sea-levels.

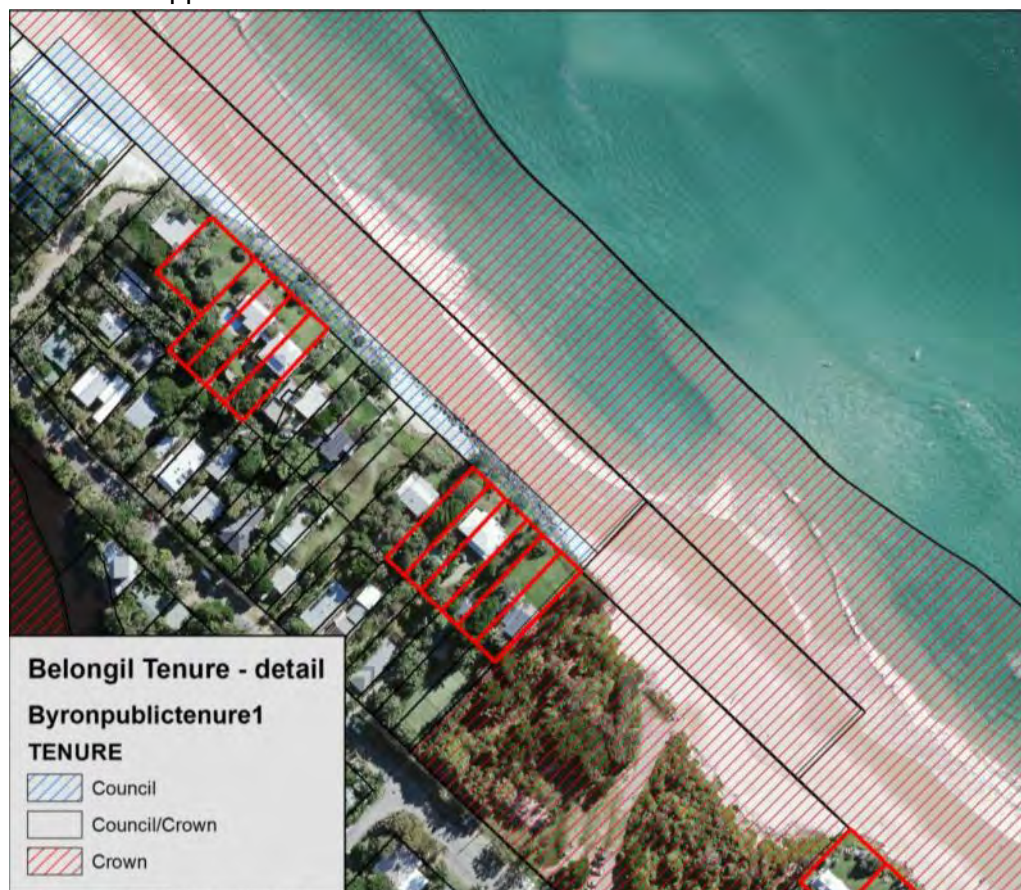
This was mapped for this submission:

From this review, and comparison with the identified footprints of the proposed walls it is evident that the applicants have misled both the public and the Coastal Panel as:

- Works at 1 and 1A Don St are intended to be on Crown reserve
- Works at 44 and 48 Childe St are intended to be mostly on the Road Reserve and partially on Crown reserve. A significant part of the development in the road reserve is outside the 10m strip of Council Road Reserve and thus on the Crown Road Reserve,
- Works at 6B Childe St are to be undertaken on the Road Reserve
- Works at 28 and 28A Childe St are to be undertaken on the Road Reserve. A significant part of the proposed development is outside the 10m strip of Council Road Reserve and thus also on the Crown Road Reserve
